Structural Analysis of DEW Line Station DYE-2, Greenland

1983-1988

Michael R. Walsh and Herbert T. Ueda

CRREL Report 98-3

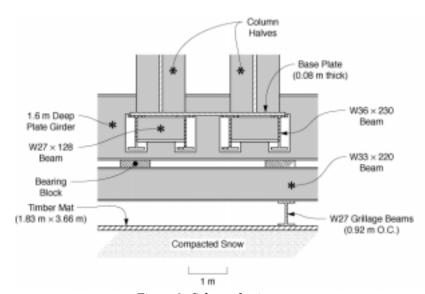
Figure 9. Column footings.

Differential settlement of the column footings is caused by differences in densification rates of the foundation snow beneath each column footing. At DYE-2, the snow was not of uniform consistency because of the presence of ice lenses of various sizes and thicknesses imbedded in the matrix of the snow. These "defects" were formed by snow melting and refreezing during the warm summer months and subsequent burial beneath drifted or fallen snow. Matrix density irregularities cause differences in the densification rate for a given load, and thus settlement irregu-

larities can occur beneath different columns. A column that settles more rapidly on its snow foundation will not support as much load as the adjoining columns, which then must assume a portion of the sunken column's load. Continued settlement will result in structural tilting and a redistribution of stresses. This results in increased stresses in the structure because of uneven loading and tilting.

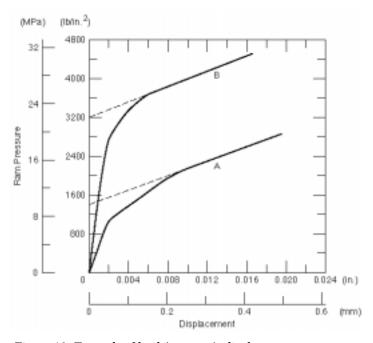
Figure 19. Example of load (pressure)-displacement measurement.

On some collars, normal sway bolt measurements could not be taken. The reasons were either bad sway bolts that could not be turned (heads missing, weld metal on threads, distorted threads, etc.) or sway bolts that had been turned all the way into their nut blocks. When this occurred, a load-deflection measurement had to be performed. To conduct a measurement, a deflection is measured for specific loads applied between the column and collar opposite the dial indicator. An example of a load-deflection measurement is shown in Figure 19. Although not highly accurate due to the influence of such uncontrollable factors as friction loads and the effect of adjacently loaded sway bolts, this measurement procedure gives approximate loads through linear extrapolation sufficient for analysis.
